ROUTINE SANITARY SURVEY REPORT

June 8, 2018

DOCKTON WATER ASSOCIATION

ID # 19550J, King County

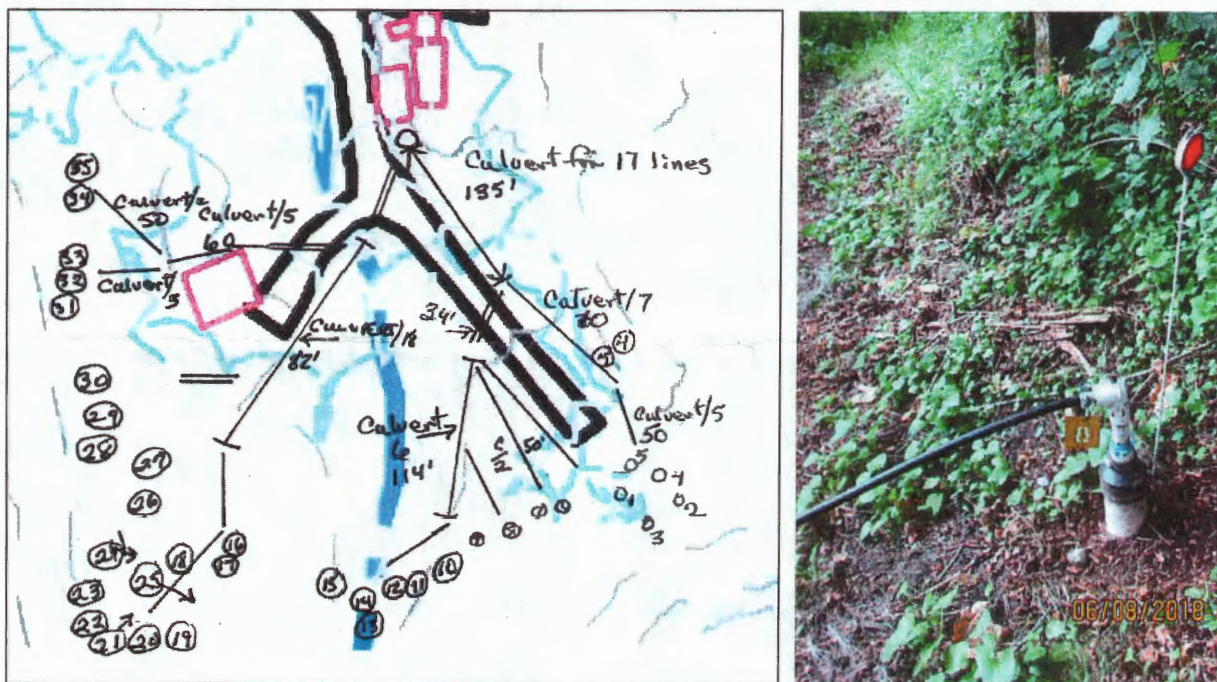
Figure 1. Dockton Springs. (Left) Map depicting the locations of the wellpoints. Pink denotes buildings; blue denotes surface water (provided by Association in 2013). (Right) Wellpoint 8. They work to keep the piping visible and out of standing water to minimize the possibility of contamination.

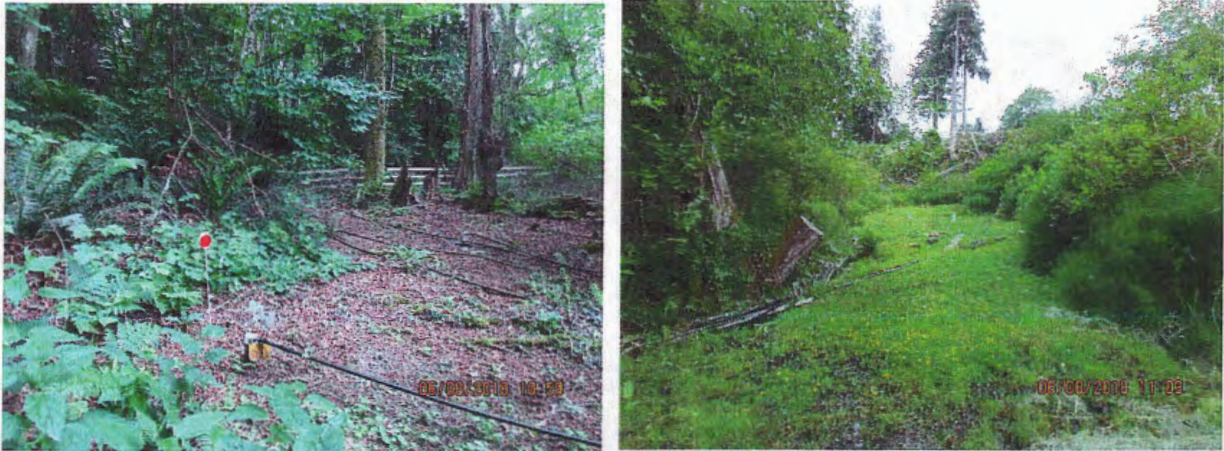
Figure 2. Dockton Springs (S01). (Left) The neighboring property has new owners since the last survey. The new owners do not have horses. (Right) The wellpoints shown here used to flow through an upper reservoir. The upper reservoir is no longer in use and all the wellpoints for Dockton Springs flow to the collection chamber.

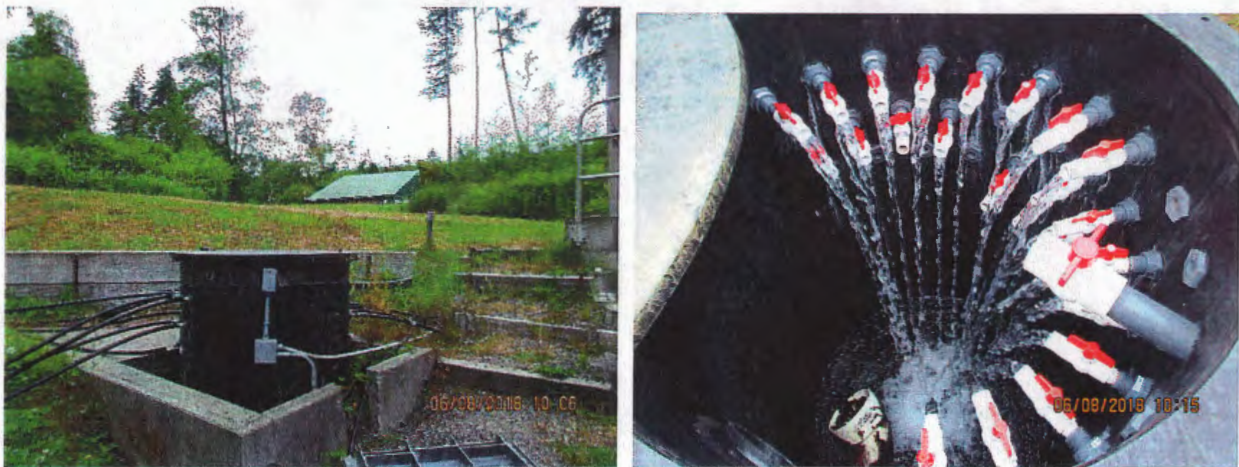
Figure 3. Collection chamber. (Left) Overview showing the black pipes from the wellpoints entering the collection chamber. The retired upper reservoir is in the background. (Right) Inside the collection chamber. The screened overflow (not 24-mesh) goes to a dedicated vault that overflows to the hillside (not shown here).

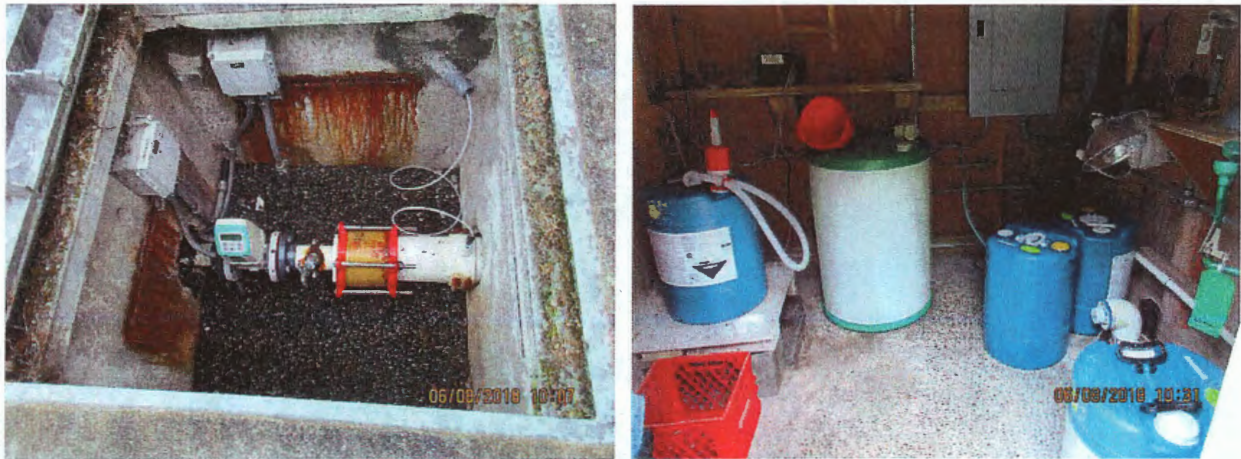
The raw water flow meter, on the line between the collection chamber and the chlorine contact tank, controls the chlorine injection flow pump (Figures 4 and 5).

Figure 4. (Left) Vault with the raw water flow meter, sample tap, and chlorine injection line. This meter controls the chlorine injection. (Right) Hypochlorite disinfection treatment plant with NSF certified hypochlorite, hose for make-up water, 3 parts water and 1 part 12.5% sodium hypochlorite, flow paced peristaltic feed pump.

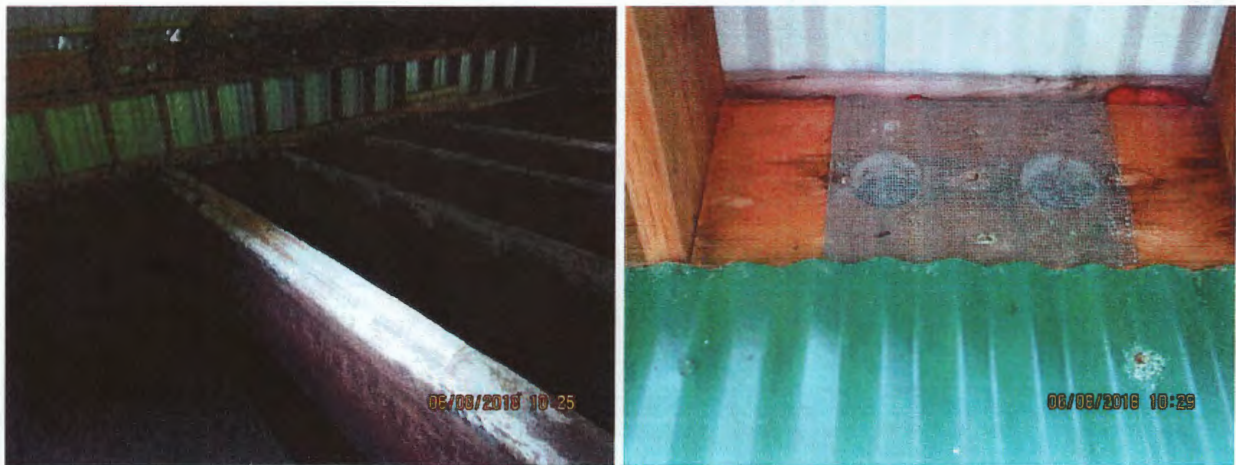
Figure 5. Baffled chlorine contact tank. (Left) View from the vertical access hatch. Purple manganese staining. (Right) Overall good screens and seals. Please double check the seal between the walls and the roof.

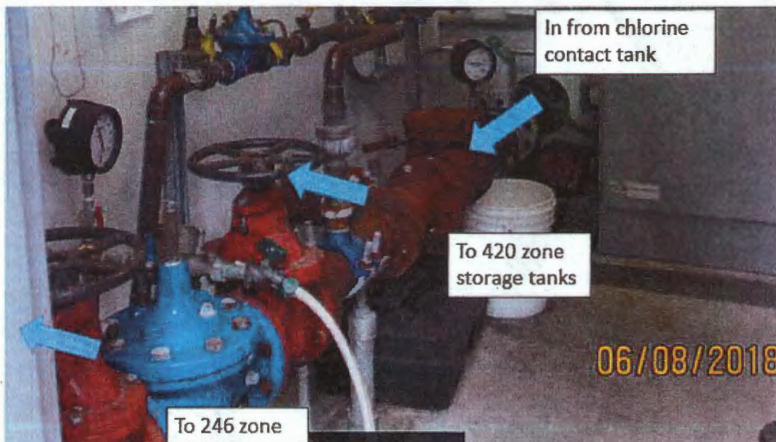
They measure flow rate and chlorine residual at entry point to distribution from the Dockton Springs booster station (Figure 6). For a maximum flow rate of 143 gpm, the minimum chlorine residual at entry point must be 0.55 mg/L for CT6. Monthly reports indicate they consistently meet the CT6 requirement.

Figure 6. Dockton Springs booster station with variable frequency drives.

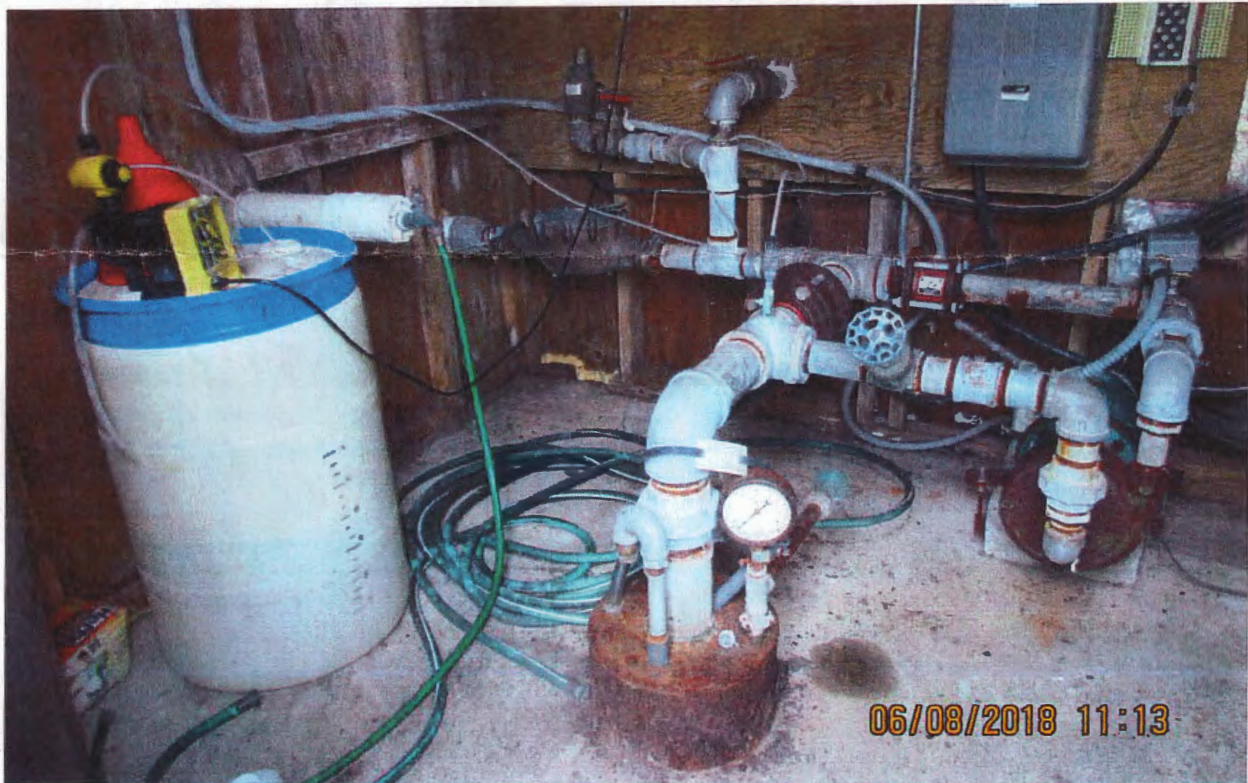
The Sandy Shores Well is used seasonally to meet peak demand (Figure 7). Manganese and iron exceed the secondary maximum contaminant levels (MCLs) (aesthetic concern). All primary MCLs (health concerns) are in compliance. The Association plans to rebuild the well house and install treatment for iron and manganese removal. WTPO1 certification will be required upon completion of the treatment plant.

Figure 7. Sandy Shores well, 100gpm Qi, and sodium hypochlorite disinfection treatment. Make up water for the hypochlorite solution fed by the hose. LMI feed pump. They keep a spare LMI feed pump and parts at the office. The sanitary control area is in good condition. Good seals and screens. The discharge line that goes out through the back wall serves as a raw source water tap. Propane back up power generator on site.

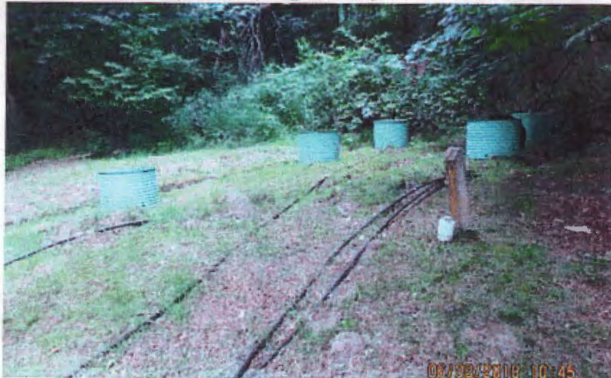
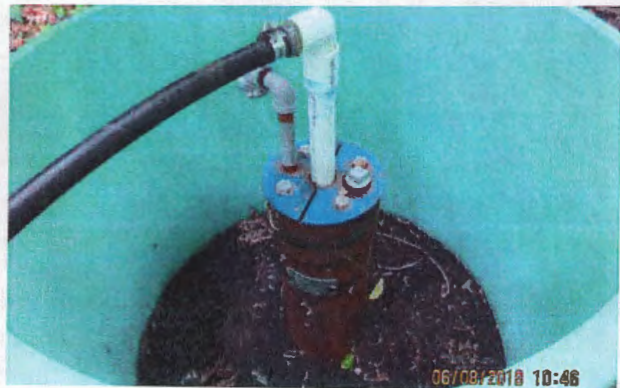
Drilled WF (S04) (Figure 8)

Figure 8. Refer to source approval report 17-0709. Please keep in mind that the wellhead plumbing is part of the approved design and should not be changed after approval.

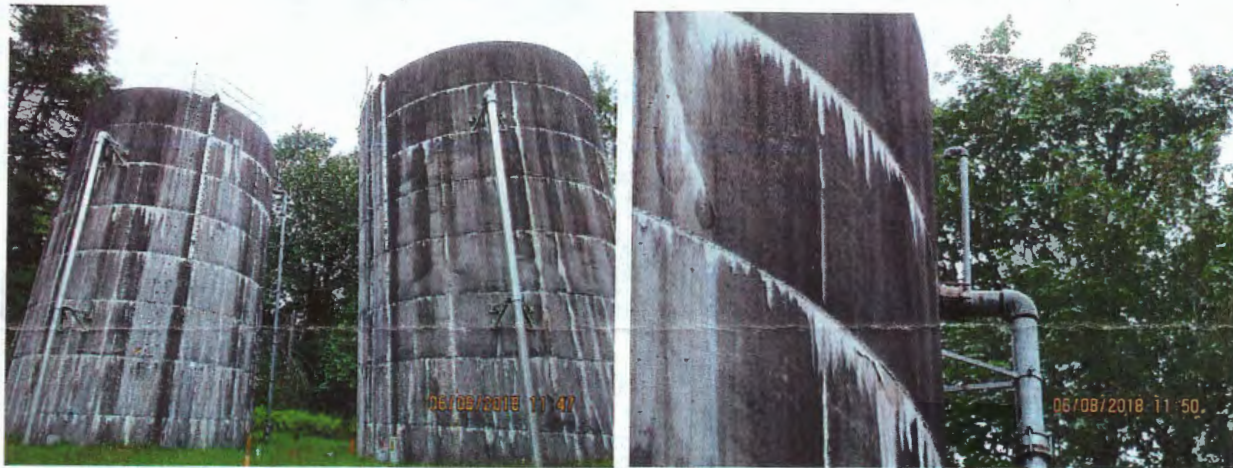
The system has two concrete storage tanks (310,000-gallons total) in the 430 pressure zone (Figure 9). The storage tanks serve the 520 pressure zone through the 520 zone booster station and the remaining pressure zones by gravity.

Figure 9. North and South storage tanks. Float control tank level controls Dockton Springs by radio transmittance. No pressure transducer. (Left) Overview. (Right) Vent on the overflow pipe.

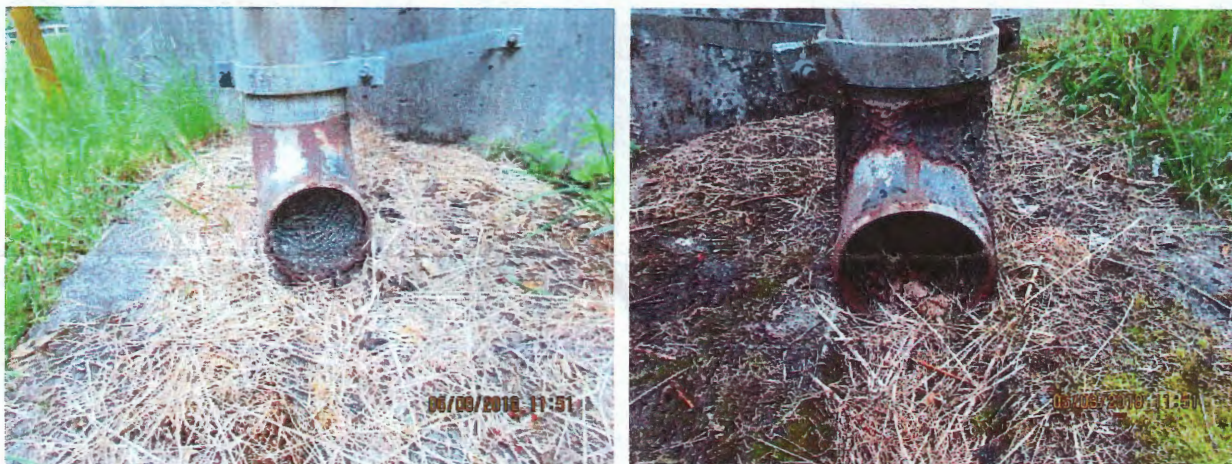
I inspected photos of North and South the storage tank access hatches, level indicator cable entry, and air vents at the Association office. The overflows need finer mesh screens to keep insects out (Figure 10). The storage tank drain line daylight is behind the fence to neighboring property (did not observe).

Figure 10. Storage tank overflows with screen (maybe 4-mesh). Overflows need 24-mesh screen to prevent insects from entering the tank. Ideally, there is an airgap.

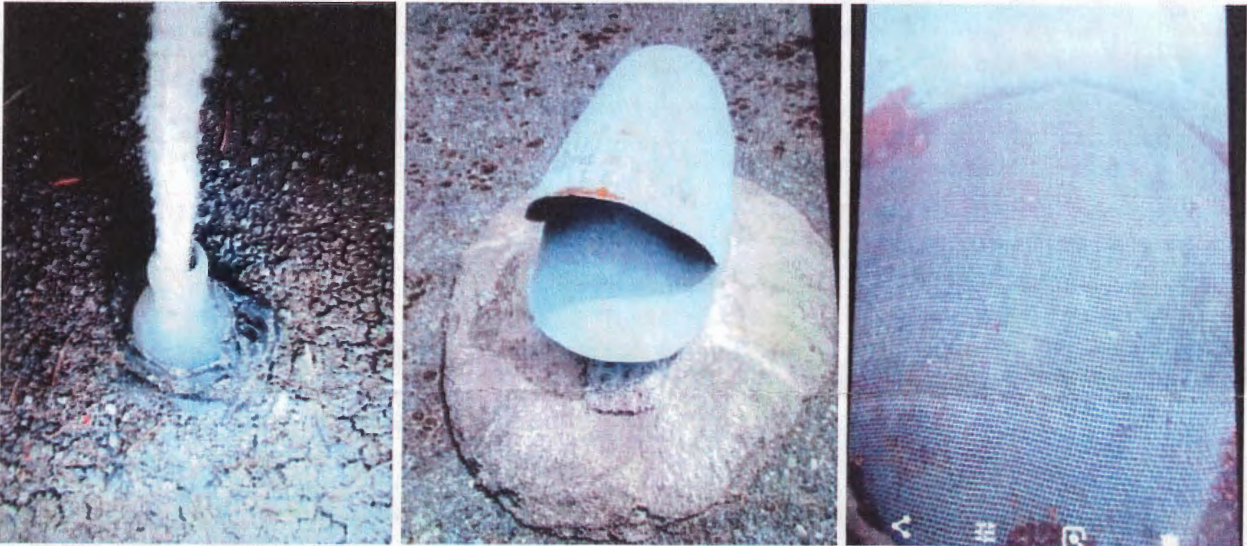
- Confirm the reservoir water level gage board cable openings are protected. – Complete. We reviewed photos during the survey. The cable enters through a rubber fitting (see Figure 11).

The access hatches and level indicator cable entry appear to protect the storage tanks from contamination (Figure 11). However, the lock hatch is on the top of the access hatch lid, which makes it more difficult to seal from rain (see photos from last survey). Think about retrofitting the access hatch so the lock is on the side of the lid and not the top of the lid. Nice job on adding the gasket seal on the storage tank access hatches.

Figure 11. (Left) Level indicator cable is covered with the metal tent. The cable enters the roof through the rubber fitting. (Center) Air vent design allows debris to collect on the horizontal screen underneath. (Right) Air vent screen. (Photos provided by the Association during the survey).

Please replace the storage tank air vents. We often observe debris accumulation on the horizontal screen of these types of air vents (Figure 11).

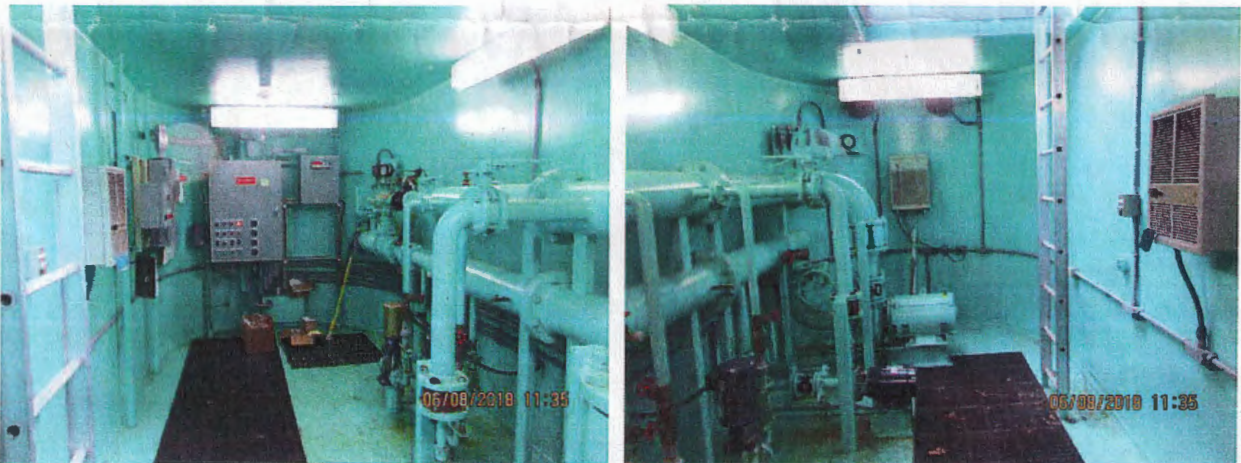
This is a constant run pump station controlled by discharge pressure (Figure 12). As a closed system (does not pump to atmospheric pressure storage in the pressure zone) it is the only source of pressure to the 520 zone. The industry standard is to provide backup power supply with automatic transfer for closed system BPSs. Please consider.

Figure 12. 520 BPS. Below grade vault. No backup power generator. Constant run pump station. (Left) Booster pump controls, cla-valve, flow meter, two 3/4hp pumps. (Right) 5hp pump, 50hp pump.
